Manhole Inspection Summary

Manhole # S63G__017MH

Insp Date: **3/26/08 9:49 AM**

Location Address: **5100 Bayview Blvd.**

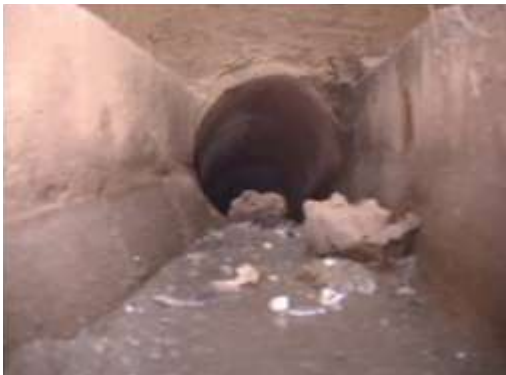
Defect 3

Condition: ☐ Sound ☒ **Cracked** ☐ Root Intrusion ☐ Loose Brick ☐ Deteriorated

Infiltration: ☐ None ☐ Joint ☒ **Cracks** ☐ Mortar ☐ Roots ☐ Wall

CRACKED BARREL NEAR BENCH.
DEFECT IS AT 1:00 IN THIS PHOTO

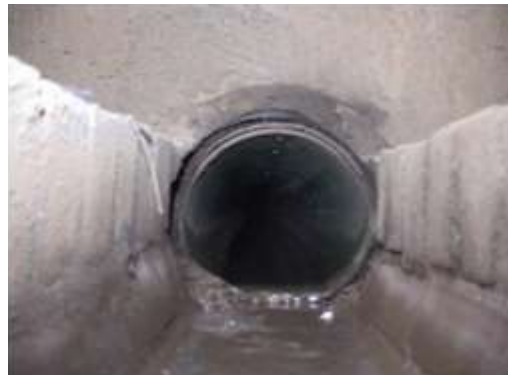
Defect 1

infiltration incoming 6. 11 o'clock to 2
o'clock

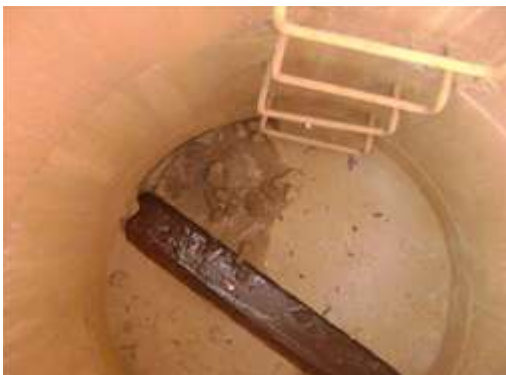
Defect 2

INFILTRATION ON BENCH

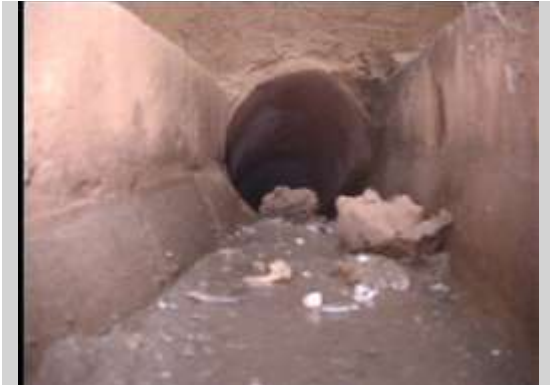
12 O'Clock Outflow

8 in. Circular Gravity Sewer
Pipe Out @ 12 O'Clock

Pipe Height: **8.4** (in.) Rod and Bar (Angled)
Pipe Material: **Clay** ☐ Pipe Lined
Invert Depth: **7.58** (ft.) Flow Characteristics: **Slow**
Deposits: ☒ None ☐ Mud ☐ Sludge ☐ Debris ☐ Grease
Silt Depth: (in.) Deposits Extent:
Infiltration: **None** Pipe Seal Cond: **Sound**

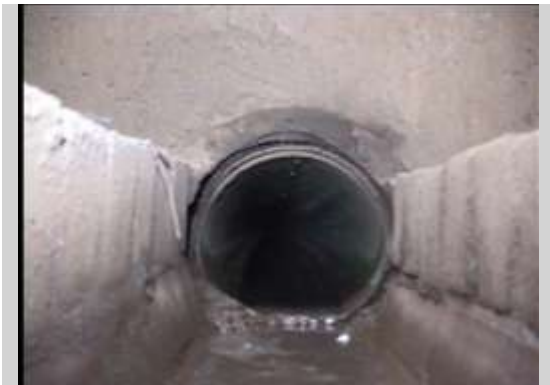
6 O'Clock Inflow

8 in. Circular Gravity Sewer
Pipe In @ 6 O'Clock

Pipe Height: **8.4** (in.) Rod and Bar (Angled)
Pipe Material: **PVC** ☐ Pipe Lined
Invert Depth: **7.46** (ft.) Flow Characteristics: **Slow**
Deposits: ☒ None ☐ Mud ☐ Sludge ☐ Debris ☐ Grease
Silt Depth: (in.) Deposits Extent:
Infiltration: **Evidence** Pipe Seal Cond: **Broken**
